TECHNICAL REPORT ARCCB-TR-01026

**COATINGS EVALUATION USING
A VENTED COMBUSTOR**

DECEMBER 2001

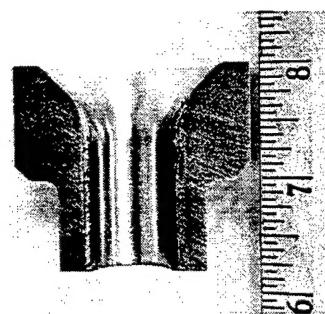
Prior to testing, the overall surface condition of the orifice insert was visually examined and photo-documented. A representative photograph of the original surface condition of an unfired HC chromium coated insert is shown in Figure 2.

Figure 2. Unfired HC chromium coated specimen.

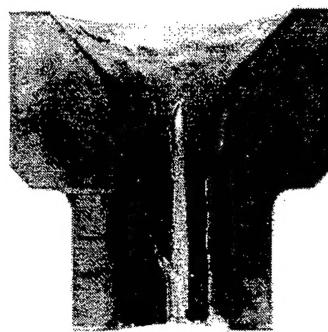
Figures 3 and 4 show the damage after twenty firings done to the HC chromium and LSA tungsten specimens, respectively.

Figure 3. HC chromium coated specimen (twenty firings).

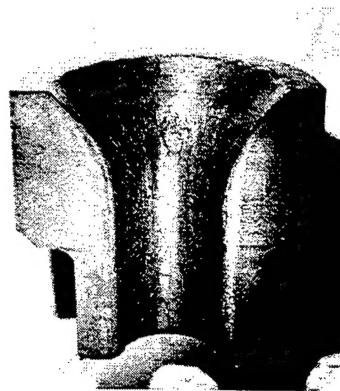
Figure 4. LSA tungsten coated specimen (twenty firings).

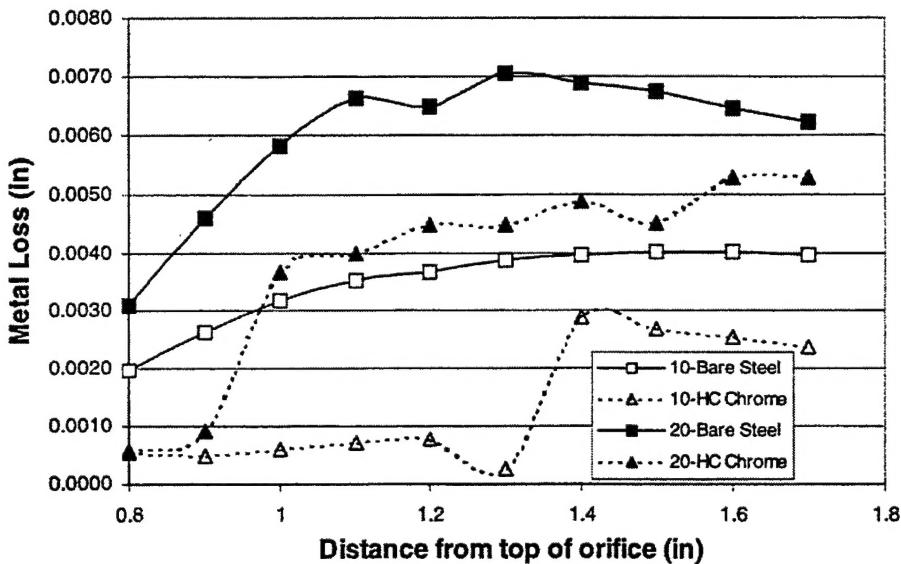
Dimensional loss measurements, obtained from a coordinate measuring machine are shown in Figure 5. The data reported starts 20.3-mm (0.8-inch) from the top of the orifice, which represents where the straight zone begins. The plot illustrates the average dimensional loss from HC chromium and bare (uncoated) steel specimens after ten and twenty firings. The hard chromium sample exhibited the lowest dimensional loss after the first ten firings; however, after twenty firings, a majority of the coating was stripped away from the surface.

Figure 5. Metal loss (inches of depth) versus distance from the top of the orifice, showing comparisons after ten and twenty firings using average values for like specimens.

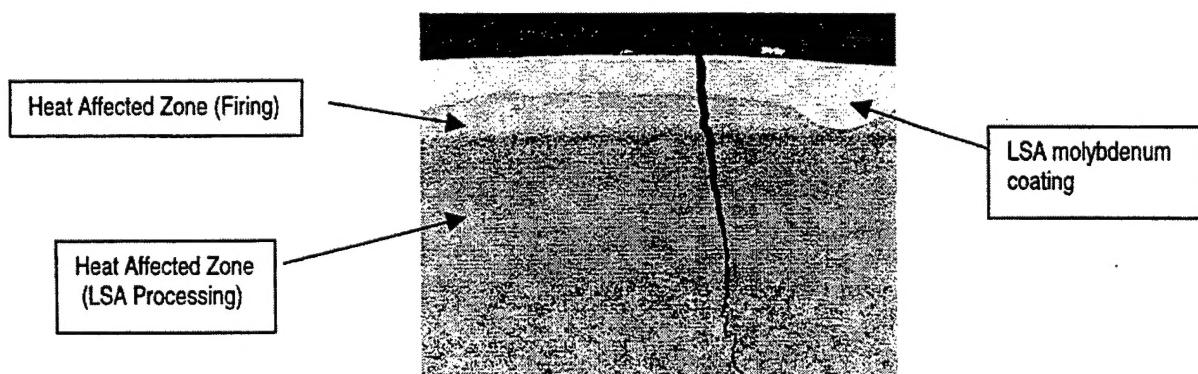
Dimensional loss measurements were also performed on the LSA specimens at the same intervals. However, due to the rough initial surface finish and the imprecision of the machining methods used, the data were purposely omitted. Metallographic examination of unfired LSA specimens identified complete coating removal had occurred in random areas during post-LSA process machining. The concern was that the data could be inaccurately interpreted when comparing the current production bore coating process to the experimental LSA process. The only LSA specimen that exhibited any remaining coating after twenty firings was the molybdenum specimen shown in Figure 6.

Figure 6. Micrograph of molybdenum specimen after twenty firings (50X).

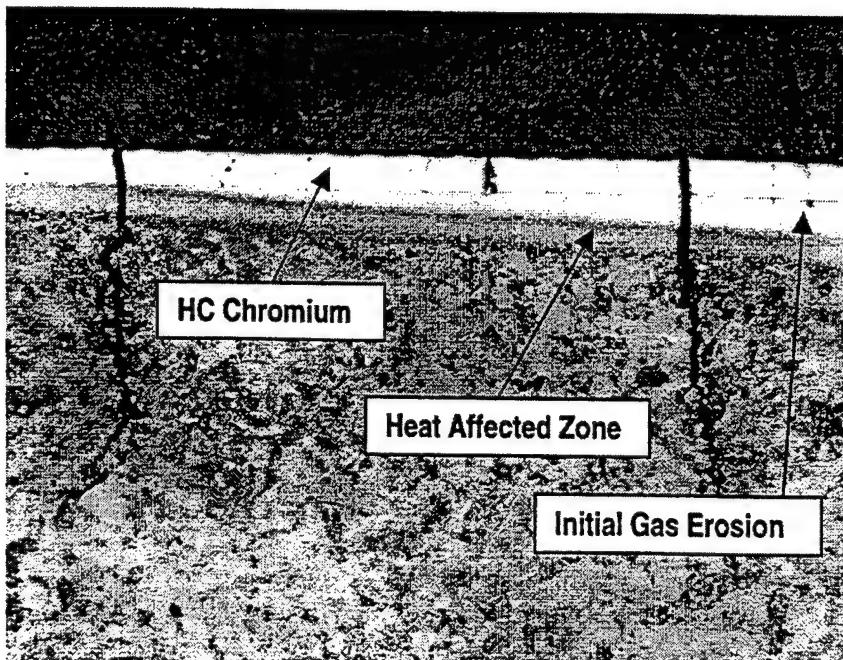
The inherent brittle nature of the hard chromium plating reveals cracks within the coating prior to exposure. The cracks form as a result of internal stress relief during coating deposition and the post-heat-treatment process (ref 2). The ensuing firing of hot propellant gases in the vented combustor exacerbates the cracking along the surface (Figure 7). The additional formation and subsequent progression of cracks into the base metal substrate are similar to those observed in a full-scale fired cannon (Figure 8).

Figure 7. Damage to HC chromium in vented combustor after twenty firings (50X).

With repeated firing, the cracks penetrate the underlying base metal through the formation of erosion pockets, which eventually lead to deep cracks in the substrate (arrows in Figures 7 and 8). The resulting damage subsequently allows spallation of chromium plating from the substrate, thus exposing the bare metal surface. The high firing temperatures quickly form a heat-affected zone consisting of untempered martensite (formed when the steel is rapidly heated to above the austenitizing temperature and then is rapidly cooled), which is inherently brittle and provides a relatively easy fracture path. In addition, the mechanism that ultimately leads to HC chromium loss and subsequent coating failure is identical, i.e., loss of HC coating through adhesive failure. Crack progression within the substrate was intergranular in both the vented combustor and full-scale cannon, suggesting corrosive attack at the grain boundaries.

The primary difference between the two specimens, shown in Figures 7 and 8, is the transformation depth of the untempered martensite. The HC chromium vented combustor specimen indicates a transformation depth of 0.0095-inch, while the transformation in the gun tube sample is 0.0012-inch. It has been established, using one-dimensional heat-flow expressions, that the temperature at the gun bore (Figure 8) surface is approximately 1210°K (ref 3). The vented combustor specimen surface temperature was approximated to be 1350°K, using the same technique. The higher vented combustor temperature is one reason why the heat-affected zone was substantially deeper. Another characteristic that is distinctly different between the two systems is the duration of a firing impulse. The vented combustor firing cycle is 0.040 second in duration compared to a duration of 0.009 second in the gun system. The difference is attributed to the greatly reduced exit flow area of the orifice compared to a large caliber cannon.

This longer firing cycle for the vented combustor is another factor contributing to the deeper substrate transformation, as the steel is held above the transformation temperature (1020°K) for a longer period of time. Another contributing factor involves the velocity of the propellant gases. The velocity of the gases passing through the vented combustor orifice is much greater, simply because there is no projectile impeding combustion gas flow. The increased velocity causes a greater convection heat transfer coefficient in the vented combustor and ultimately results in a higher heat transfer rate (ref 4). There is also a substantial pressure difference between the two systems, whereby the actual gun system exhibits a greater pressure. Although pressure plays a role in the heat transfer rate, it has recently been shown that thermal shock effects, independent of other parameters, at ambient pressures can produce the damage seen in gun bores (ref 5).
